Manhole Inspection Summary

Manhole # S55C2_006MH

Insp Date: **6/10/09 1:42 PM**

Location Address: **3701 Leo St.**

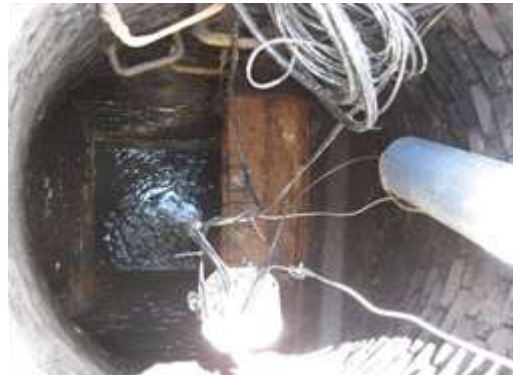
Top View

All stairs visible in this photo

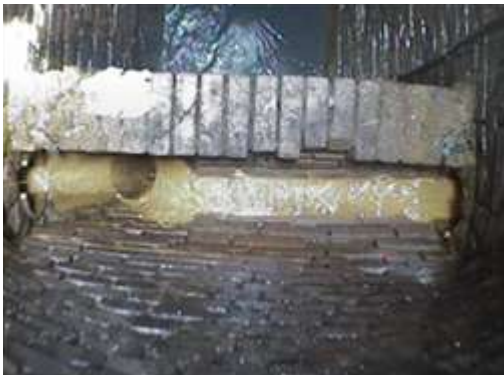
Comments **Inside drop connection combines 3- and 9-o'clock pipes in a channel that drops down to trunk line below**

3 oclock and 9 oclock combined drop.

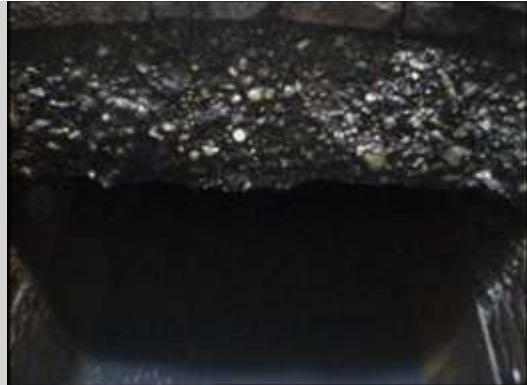
12 O'Clock Outflow

54 in. Circular Gravity Sewer
Pipe Out @ 12 O'Clock

Pipe Height: **50.4** (in.) Rod and Bar (Angled)
Pipe Material: **Concrete** ☐ Pipe Lined
Invert Depth: **20.68** (ft.) Flow Characteristics: **Fast**
Deposits: ☐ None ☐ Mud ☐ Sludge ☒ **Debris** ☐ Grease
Silt Depth: **4** (in.) Deposits Extent: **Heavy**
Infiltration: **None** Pipe Seal Cond: **Cracked**

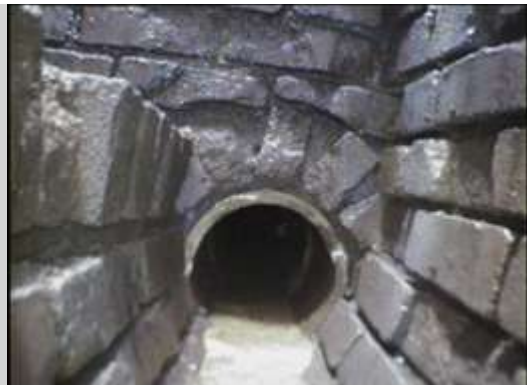
3 O'Clock Inflow

10 in. Circular Gravity Sewer
Pipe In @ 3 O'Clock

Pipe Height: **10.8** (in.) Rod and Bar (Angled)
Pipe Material: **Clay** ☐ Pipe Lined
Invert Depth: **11.88** (ft.) Flow Characteristics: **Fast**
Deposits: ☒ None ☐ Mud ☐ Sludge ☐ **Debris** ☐ Grease
Silt Depth: (in.) Deposits Extent:
Infiltration: **None** Pipe Seal Cond: **Sound**

Drop: **Inside** **Direct**
Angled: **Yes** Reading: (ft.)
Inv Depth: **20.68** (ft.)

Drop Condition: **Open**

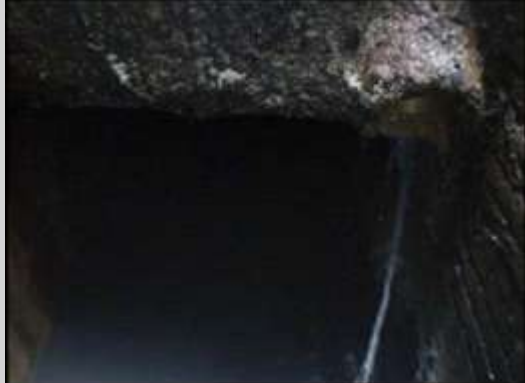
6 O'Clock Inflow

including 3 oclock and 9 oclock combined drop

Deposits: ☐ None ☐ Mud ☐ Sludge ☒ **Debris** ☐ Grease

Silt Depth: **4** (in.) Deposits Extent: **Heavy**

Infiltration: **None** Pipe Seal Cond: **Cracked**

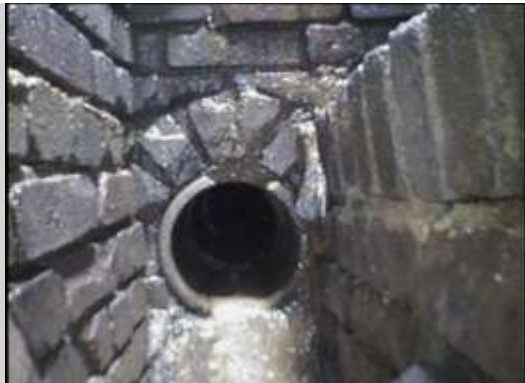
9 O'Clock Inflow

8 in. Circular Gravity Sewer

Pipe In @ 9 O'Clock

Deposits: ☒ **None** ☐ Mud ☐ Sludge ☐ Debris ☐ Grease

Infiltration: **None** Pipe Seal Cond: **Sound**

Drop: **Inside**

Drop Condition: **Open**
